Bioelectrochemistry

Corrosion behaviour and biocorrosion of galvanized steel water distribution systems

F. Delaunois, F. Tosar, V. Vitry*

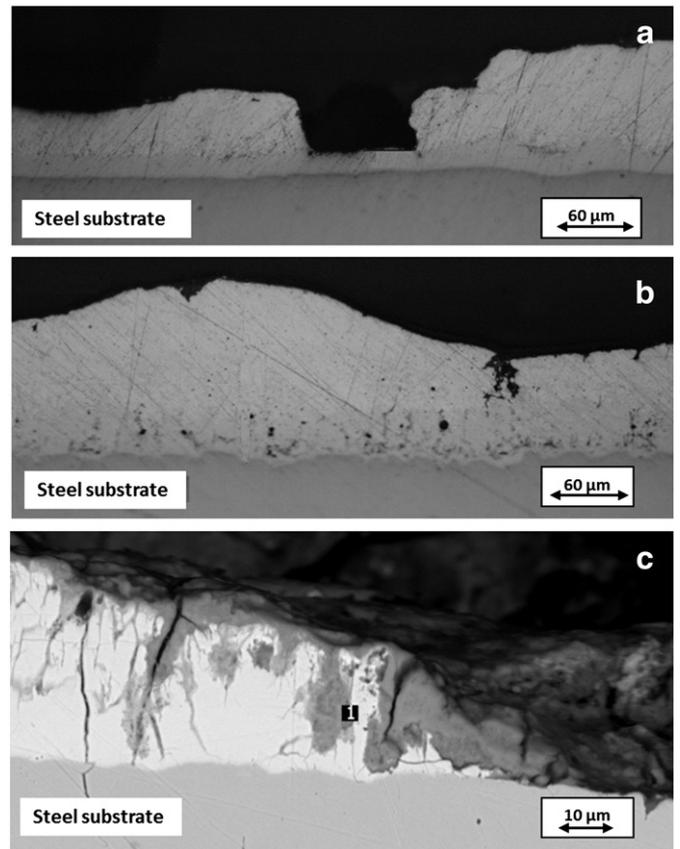
Fig. 5. Optical micrographs of Zn coating defects such as Zn lack (a), overthickness of Zn coating (b); SEM micrograph of Zn coating presenting internal cracks.

Tubes in the as-received conditions have been observed by stereomicroscopy and optical microscopy. The bare steel tube presents a classical microstructure with a ferritic matrix and tertiary cementite at the grain boundaries. The steel of galvanized tubes presents a structure with a majority of proeutectoid ferrite and a small amount of perlite. Some defects can be observed on the welding of large galvanized steel tubes, such as blisters or cracking (Fig. 4). Important irregularities of the coating thickness can also be observed: from nothing to about $100 \mu\text{m}$, and sometimes more (Fig. 5(a) and (b)). The European standard EN 10240 imposes a minimum of $55 \mu\text{m}$ of zinc at the interior side of the galvanized steel tube, and $28 \mu\text{m}$ on the welding [10]. Measurements of galvanized coating thickness along a 10 cm long section of tube show that the standard is most of the time not respected (Table 1). Moreover, the average thickness of this sample ($41.5 \pm 8.6 \mu\text{m}$) is less than that required by the European standard. A precise observation (by SEM) of the galvanized coating also shows the presence of internal cracks (Fig. 5(c)).

in the coating, near the substrate, and sometimes even inside the substrate (Fig. 4). In Table 1, we have observed important irregularities of the coating thickness, with coatings not following the European standard (which imposes a minimum thickness of 55 μm on the inside of galvanized steel tubes, and 28 μm on the welding). Moreover, the metallographic structure of the zinc coating itself does not correspond to expectations: the outer protective pure zinc eta (η) layer is sometimes too thin to offer effective protection against corrosion to the steel substrate and can even be absent in some cases (Fig. 5).

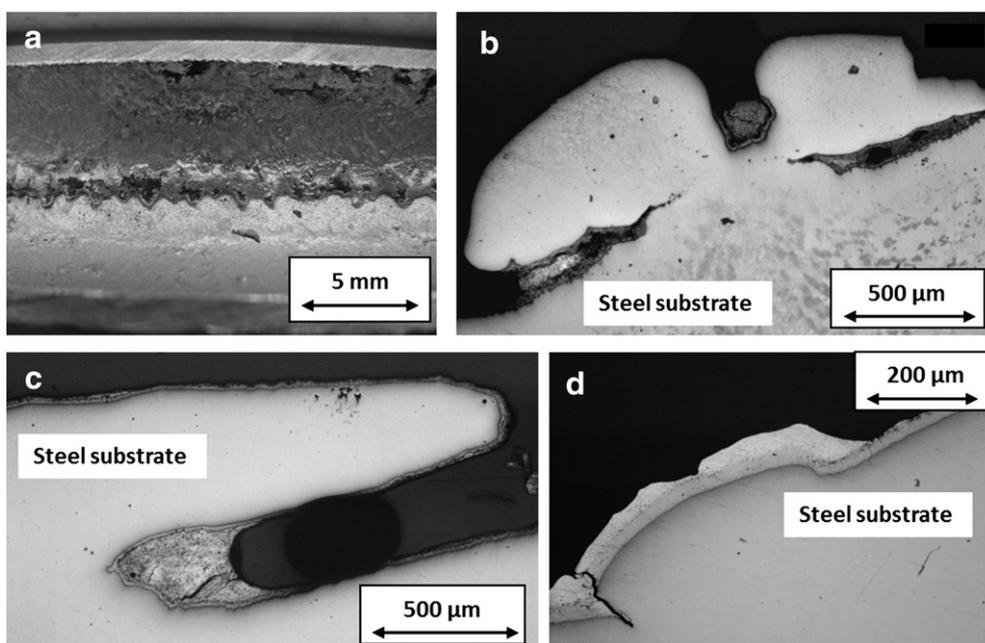
Fig. 4. Optical micrographs of welding defects in large galvanized tubes (a), such as blister (b and c) or internal crack (d).

Standard corrosion phenomena do not suffice to explain all the cases of pipe failures. Therefore, new metallographic investigations on galvanized steel tubes and on the zinc coating itself were performed. Results showed the frequent occurrence of defects in the welding, such as blisters or cracks, and also in the coating. Cracks have been identified

All these observations allow us to say that many pipe failures in potable water distribution system are notably due to the bad quality of the galvanized coating and to defects in the welding.

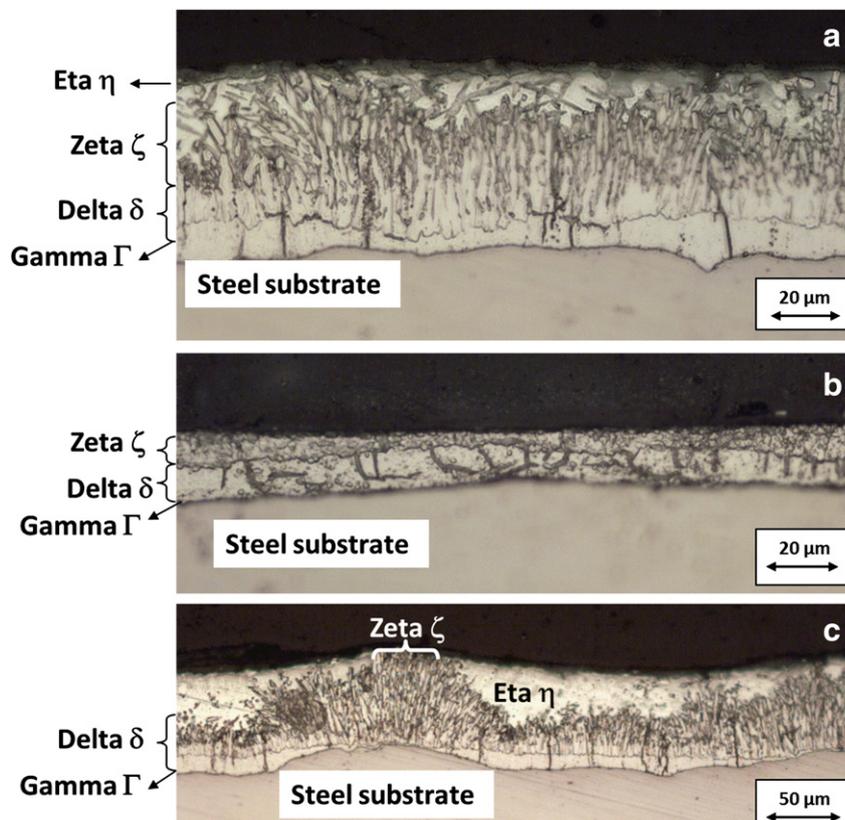
Fig. 6 shows moreover that, even when the minimum thickness of $55 \mu\text{m}$ is respected, the microstructure of the galvanized coating can be inadequate, with an outer protective pure zinc eta (η) layer too thin to ensure effective protection of the steel substrate against corrosion (Fig. 6(a)). When the coating is very thin (less than $20 \mu\text{m}$) (Fig. 6(b)), its structure is composed of nearly 50% delta (δ) layer–50% zeta (ζ) layer, and the outer protective pure zinc eta (η) layer is missing. In some cases, irregularities of the galvanized coating lead to a too thin pure zinc eta (η) layer, with a zeta (ζ) layer reaching the surface of the coating with a lack of delta (δ) layer in some places, impeding protection of the steel substrate against corrosion (Fig. 6(c)).

Fig. 6. Optical micrographs of hot-dip galvanized steel defects (etched with 4 vol.% Nital), such as too thin η -layer (a), missing η -layer (b) and irregularities as ζ -layer reaching the surface (c).

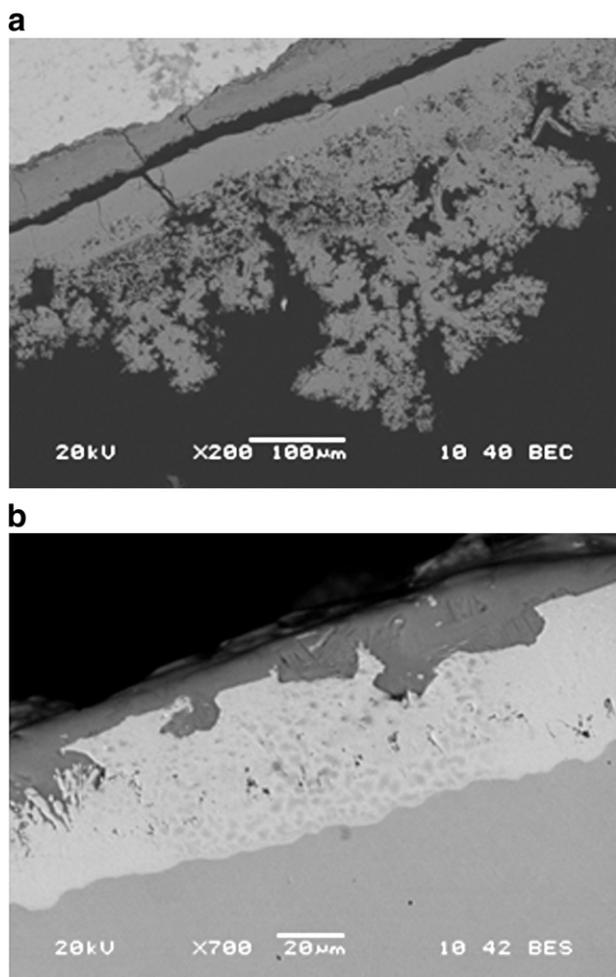
After 6 months of use in the sanitary system installed in our laboratory, samples of the galvanized and of the bare steel tube have been isolated and prepared for SEM and EDS analyses. The bare steel tube presents a strong (as expected) internal generalized corrosion (Fig. 13(a)). The measurement of the tube thickness shows a consumption of $10 \mu\text{m}$, and thus a corrosion rate of $20 \mu\text{m}/\text{y}$. The galvanized steel tube also presents a corrosion film and the dissolution of the η phase of the zinc coating (Fig. 13(b)).

EDS analysis of tube surfaces (Table 3) show the oxidation of iron or zinc, as expected, and different elements coming from water (Ca, Si, P, ...). Sulphur and chlorine are also detected in the two tubes, with bigger amounts of both elements in the galvanized one.

Fig. 13. SEM micrographs of bare (a) and galvanized (b) steel tubes after 6 months of use in sanitary system in laboratory.

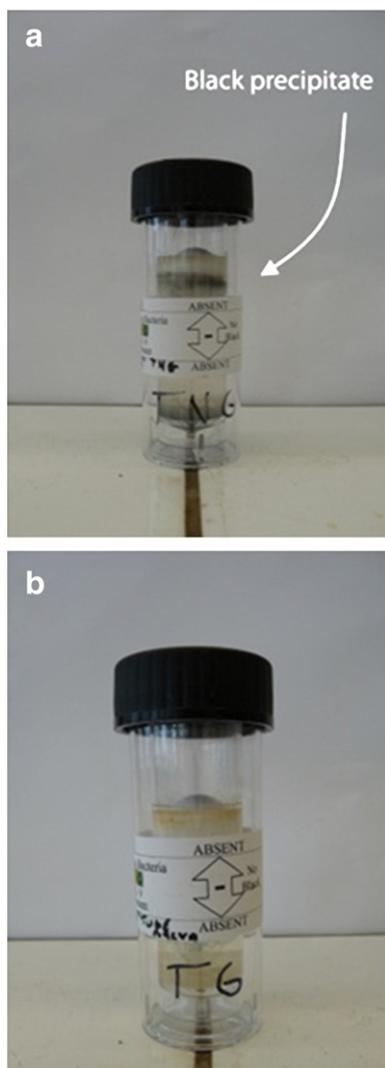
The bare steel tube was the first to react with BART test all along the test time. Bacteria community is thus more important in bare steel tube than in galvanized steel one. Moreover, if reaction times (at 2 and 6 months) are compared for each tube, it is noted that it strongly decreased although the culture time was also shortened.

Fig. 14. BART²
² BART: Biological Activity Reaction Test. test for water seeping out the bare (a) and galvanized (b) steel tubes.

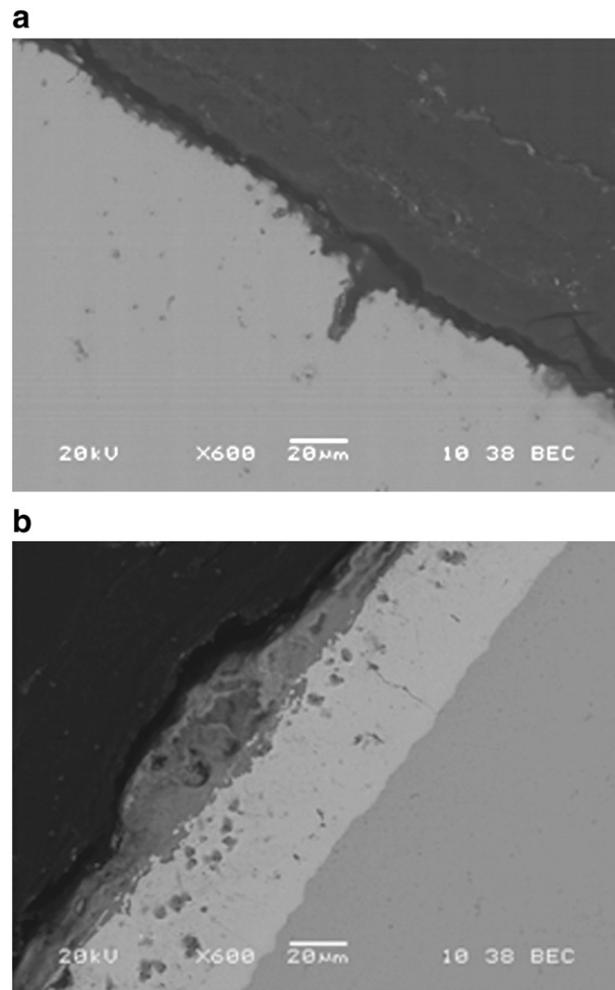
SEM observation of the internal surface of the bare steel tube (Fig. 15(a)) shows generalized corrosion with some pitting. The galvanized steel tube (Fig. 15(b)) presents an important corrosion penetration: 10 µm of the zinc coating is affected and some micro-cracks are observed. This corrosion differs from the pitting corrosion observed in other works [25].

Fig. 15. SEM micrographs of bare (a) and galvanized (b) steel tubes after 10 days in culture medium.
