THE RECOURSE TO CUTTING-BASED TOMOGRAPHY FOR QUANTIFYING THE SURFACE STRENGTHENING OF ALTERED STONES

Laurent Van Parys^a, Fabrice Dagrain^a and Laurent Leoskool^a

^a *University of Mons – Faculty of Engineering – Department of Civil Engineering
and Structural Mechanics, Place du Parc 20, 7000 MONS (Belgium)*

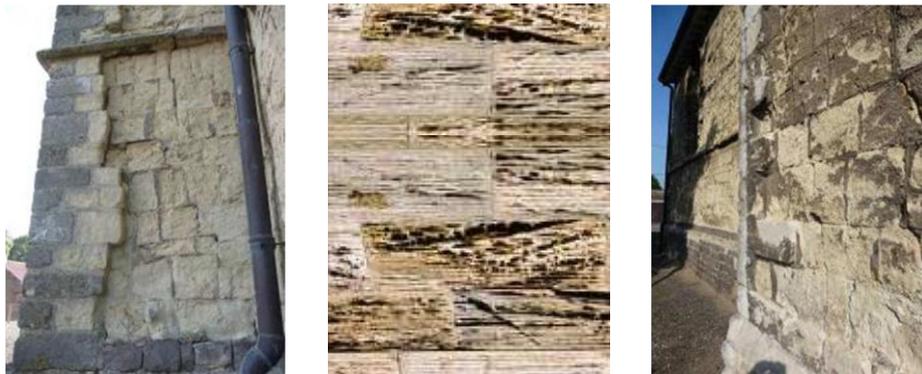
Figure 1: unfixing (left), loss of matter (centre) and cracking (right) [after 5]

The first family concerns **unfixing** (cleavage, burst, blister...), that occurs as aggregates, flakes or leaves become removed, progressively exposing the internal surface of stones. The alteration can be evolving and then lead to structural problems. It can have a wide range of causes, like action of salts, heterogeneity of stone properties, thermal strengths or overloads. The second family gathers alterations associated with **loss of matter** leading to the appearance of cavities to the stone surface, altering

roughness, texture and sometime blocks outlines. The cavities size can vary from a few millimeters to a few centimeters. Generally, they affect only the surface of materials and they do not progress in the depths of the matter. The main causes are frequently anthropic or atmospheric factors. **Cracking** constitutes the third family of listed alterations, classified in two categories (micro-cracks and macro-cracks). Such a problem is often serious as it announces a possible rupture of a building part. Moreover it permits to potentially aggressive agents like water to migrate in depth and accelerate the phenomena, e.g. by the action of frost/defrost cycles.

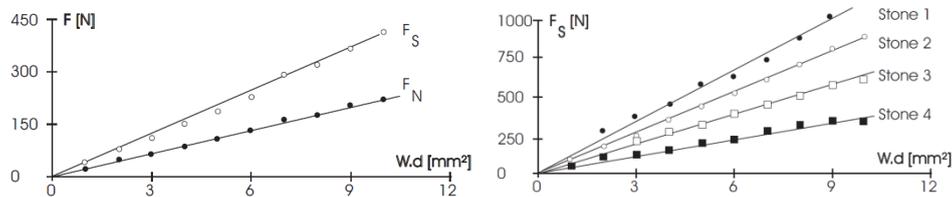
Figure 3: one stone $F_{s,n} = F_{s,n}(w.d)$ – Several stones $F_s = F_s(w.d)$

Stone cutting is associated with a "ductile" or a "brittle" mode of failure depending on the depth of cut. The ductile mode takes place at shallow depth of cut and is associated with a plastic flow, while the brittle mode occurs above a threshold depth of cut and is characterized by the propagation of a tensile crack. It was shown that, within the ductile regime, the magnitude of the force acting on a sharp cutter, averaged over a length s many times the depth of cut ($s \sim 5$ to 10 mm) is found to increase linearly with the cross-section area of the groove being traced, what is expressed through the equation 1.

$$F_{cs} = \epsilon \cdot w \cdot d \quad (1)$$

where ϵ is the intrinsic specific energy.

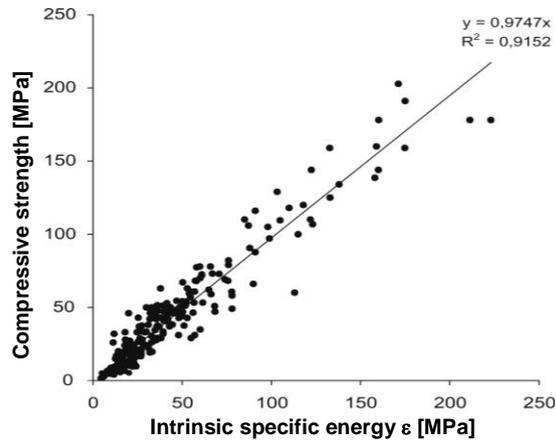
Figure 4: correlation between ϵ and q for geomaterials & building materials

Numerous scratching tests were conducted at the University of Mons on several types of geomaterials (stones, clays, mortars). For each of them, the tests were conducted with sharp cutters at depth of cut ranging from 0.1 to 1 mm. Particular attention was given to avoid the occurrence of chipping and to control the cutter state of sharpness. In parallel, compression tests were conducted on the same rock materials; as much as possible the tests were performed on the same samples (cylinders of 25 mm diameter and 50 mm length). It was found that a minimum of three grooves (at different depth of cut) must be traced to provide a precise estimation of the material strength. The intrinsic specific energy was identified with the slope of the best linear fit conducted on data points in the $F_s = F_s(w.d)$ diagram.

This strong correlation shows that the translational cutting test is efficient on a great range of homogeneous materials, even for poor value of compressive strength. The transpositions to altered materials essentially concern the adaptation of the load cell to the specific range of cutting forces and some software implementations.

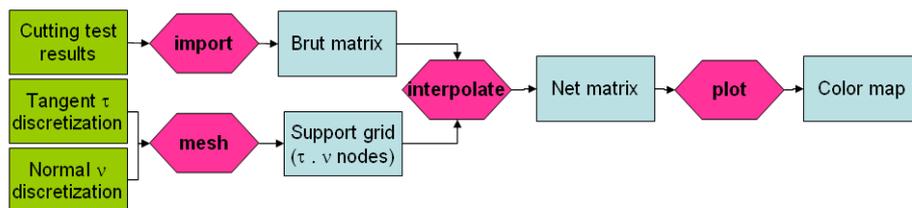
Figure 5: algorithm for simplified establishment of a color map

Disposing of a technique likely to provide a local value of material strength, the main problem will now concern the data management. In fact, a low value for the cutting depth d ($\sim 125 \mu\text{m}$) and the velocity v ($\sim 100 \text{ mm/sec}$) combined with a high frequency ($\sim 800 \text{ Hz}$) and a number of cuts per groove (~ 150) leads to collect one value of strength at around each $100 \mu\text{m}$ of spatial interval. Further than the analysis of impressive data matrix, the authors proposed to rely on some kind of data mapping: the recorded strength values will be used as the basis for a spatial interpolation that will later become coupled with classical visualization facilities (color code associated with the measured value of the strength). In practice, a basic implementation of this concept may be implemented inside the MATLAB environment under the shape of stand-alone routines.

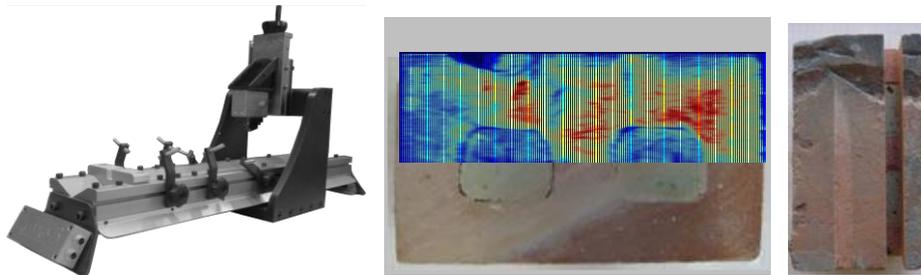
Figure 6: commercial device (left), mapping (centre) and top groove (right)

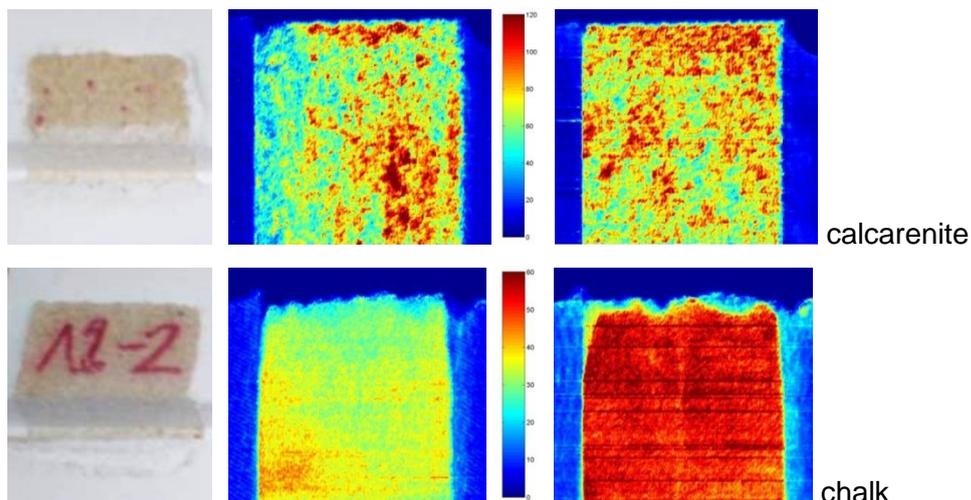
Figure 7: stone sample (left), map before and 21 days after treatment (right)

The combination of the presented technologies may then be used for illustrating in what manner the specificities of a stone type may influence the effectiveness of an eventual strengthening treatment. The illustration concerns two types of stones: respectively a calcarenite and a massive chalk, both of them being affected by salt weathering. The stone samples have been tested before any treatment for establishing a reference map. Then, three applications of ethyl-silicate are performed with each time 48 ours delay. The stone samples are then tested again 7, 14 and 21 days after the last ethyl-silicate application. The color maps show that the strengthening effect may be clearly observed on the massive chalk that was characterized by its very low initial characteristics although it remains less impressive on the calcarenite.

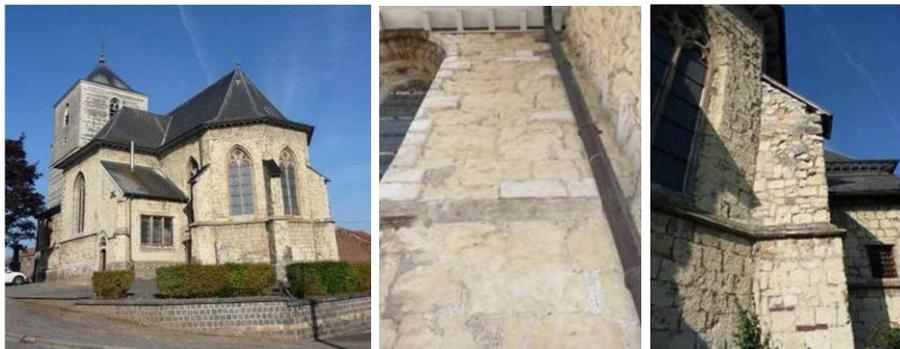
Figure 8: church view (left), altered wall (centre) and buttress (right)

The case study concerns the Saint-Christophe stone masonry church located in Racourt (Belgium) and is representative for a great number of civil or cultural buildings erected since the Roman period in an important area located between Brussel and Liege. The considered monument has been erected during the XIVth and XVth centuries, according to a combination of Romanesque and Gothic styles. It has been partly erected using a stone called “Tuffeau de Lincant” that was locally extracted and used for building despite the fact it later revealed as highly sensitive to alteration or degradation phenomena. The studied church suffers various degradations like unfixing or loss of matter affecting a great number of structural members (walls, buttresses) playing a strategic role in the stability. In practice, the serious state of degradation led to initiate a great restoration campaign, financially supported by the civil authorities. Facing the alteration problem, the situation appeared as delicate and justified a sharp approach of the problems.

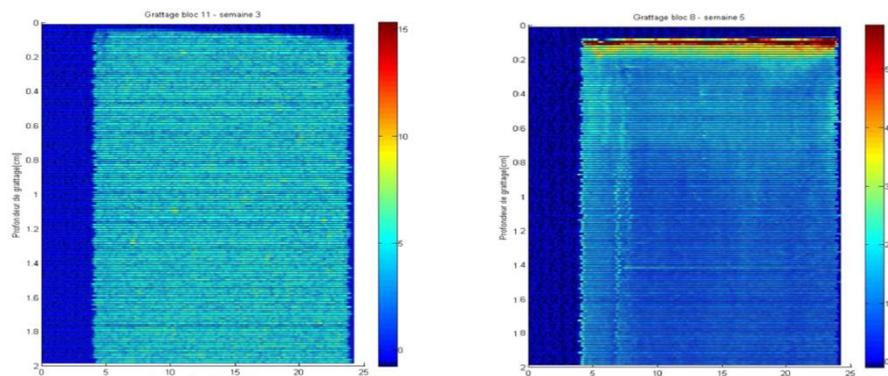
Figure 9: treatment with lime water (left) and ethyl-silicate (right)

the Heritage Administration in Belgium for improving the quality of altered materials (lime water and ethyl silicate solution) has been studied. For each product, two kinds of practical processes have been investigated: brush application and capillary aspiration. For each solution, the evolution of strength levels as well as the progression of the strengthened zone with the time has been carefully studied with the help of the cutting-based tomography. In this framework, the short term effectiveness of ethyl silicate has definitely been outlined while lime water treatments have illustrated their limitations. Then, the treatment of the “Tuffeau de Lincen” has also been investigated, only with ethyl-silicate and only a limited surface strengthening effect has been noticed.
