Study of PFAS pollution affecting a groundwater pumping site in a chalk aquifer (Mons – Belgium)

Project Background

The pilot site in Nimy (Mons) was selected to characterize and investigate the origin and transport pathways of the contamination. The site includes 11 production wells reaching depths of up to 100 m, along with approximately 60 shallower piezometers that intercept the chalk aquifer. It supplies an average of 14 million m³ of water per year. Key questions remain regarding the interactions between aquifer compartments, potential pollution sources, the influence of local watercourses, and preferential flow paths.

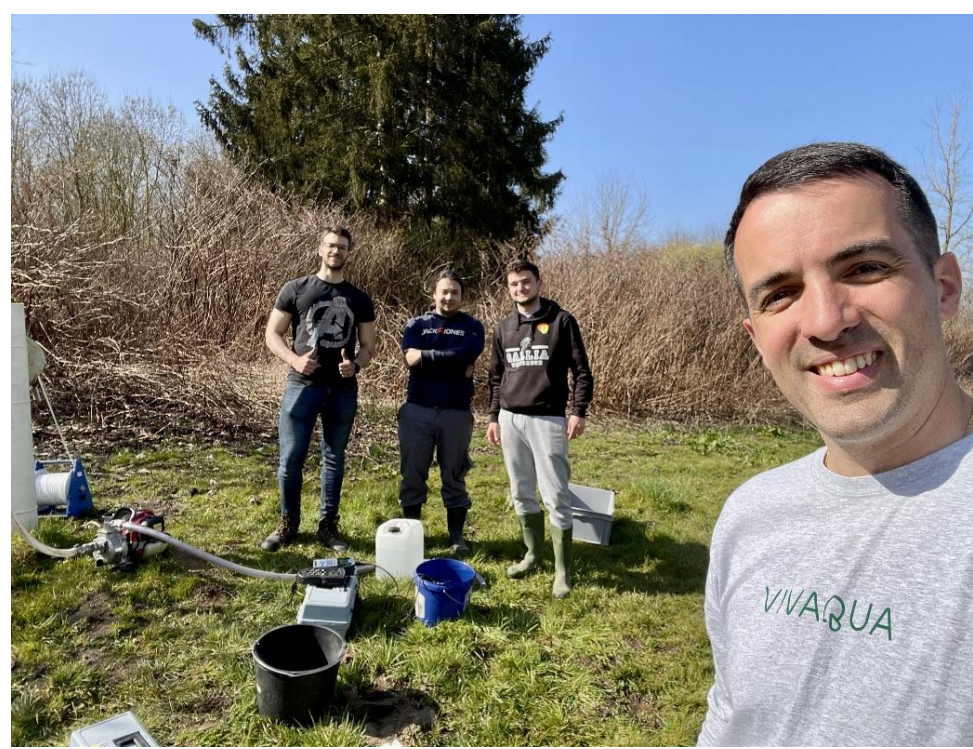
Sampling Campaign

In March 2025, 46 piezometers were sampled.

A wide range of analyses was conducted, including PFAS analysis.

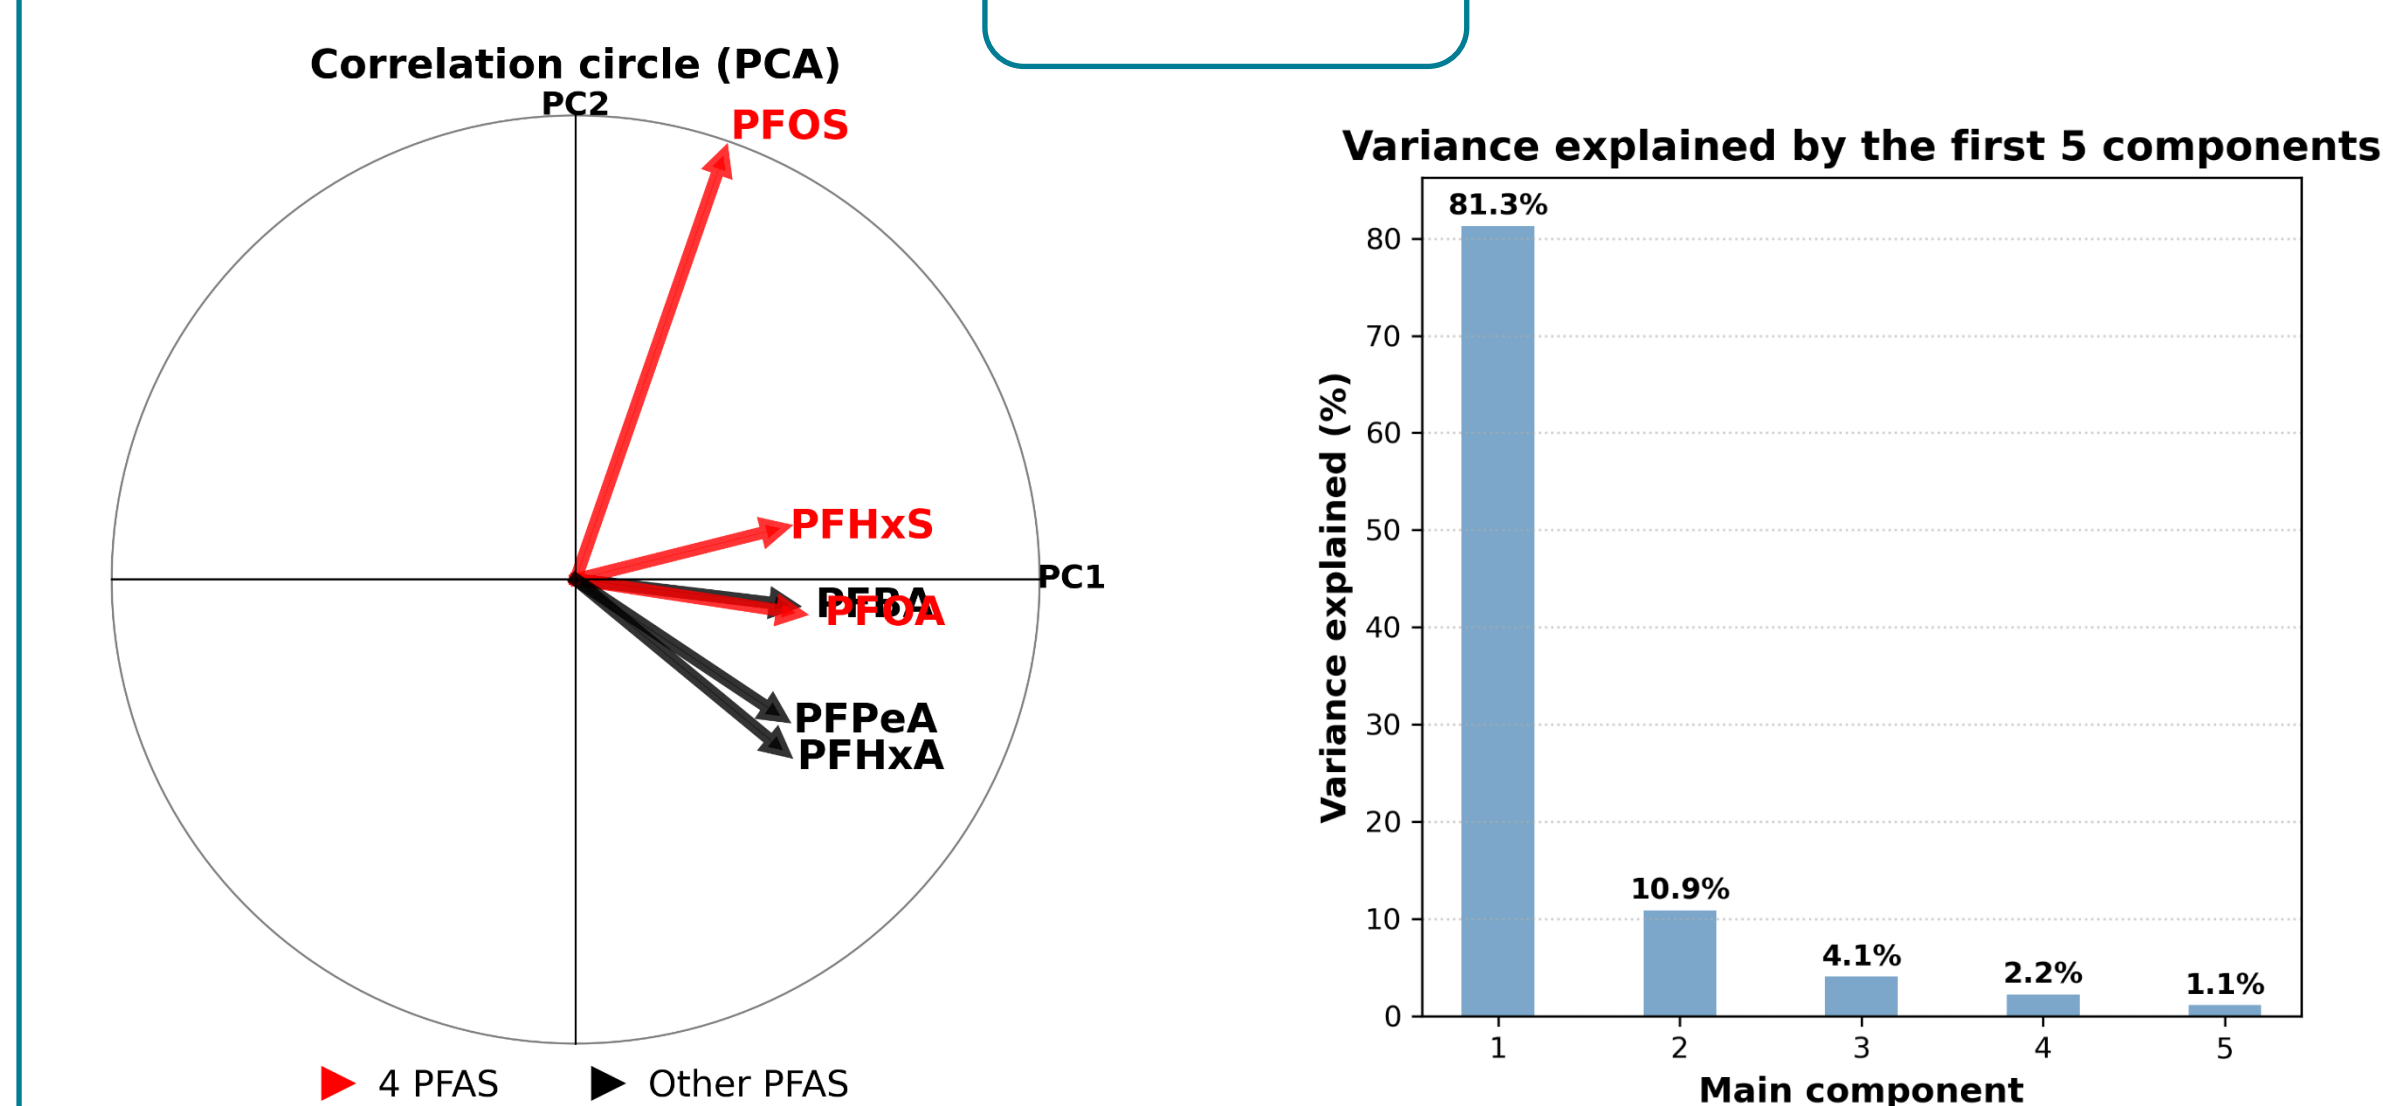
PCA

Principal Component Analysis (PCA) was used to reduce the number of variables and better visualize relationships between PFAS compounds.

Only six PFAS with a normal distribution were included in the analysis. The correlation circle shows that PFOS appears less correlated with the other compounds, suggesting a distinct behavior. This observation is consistent with its spatial distribution shown on the maps above.

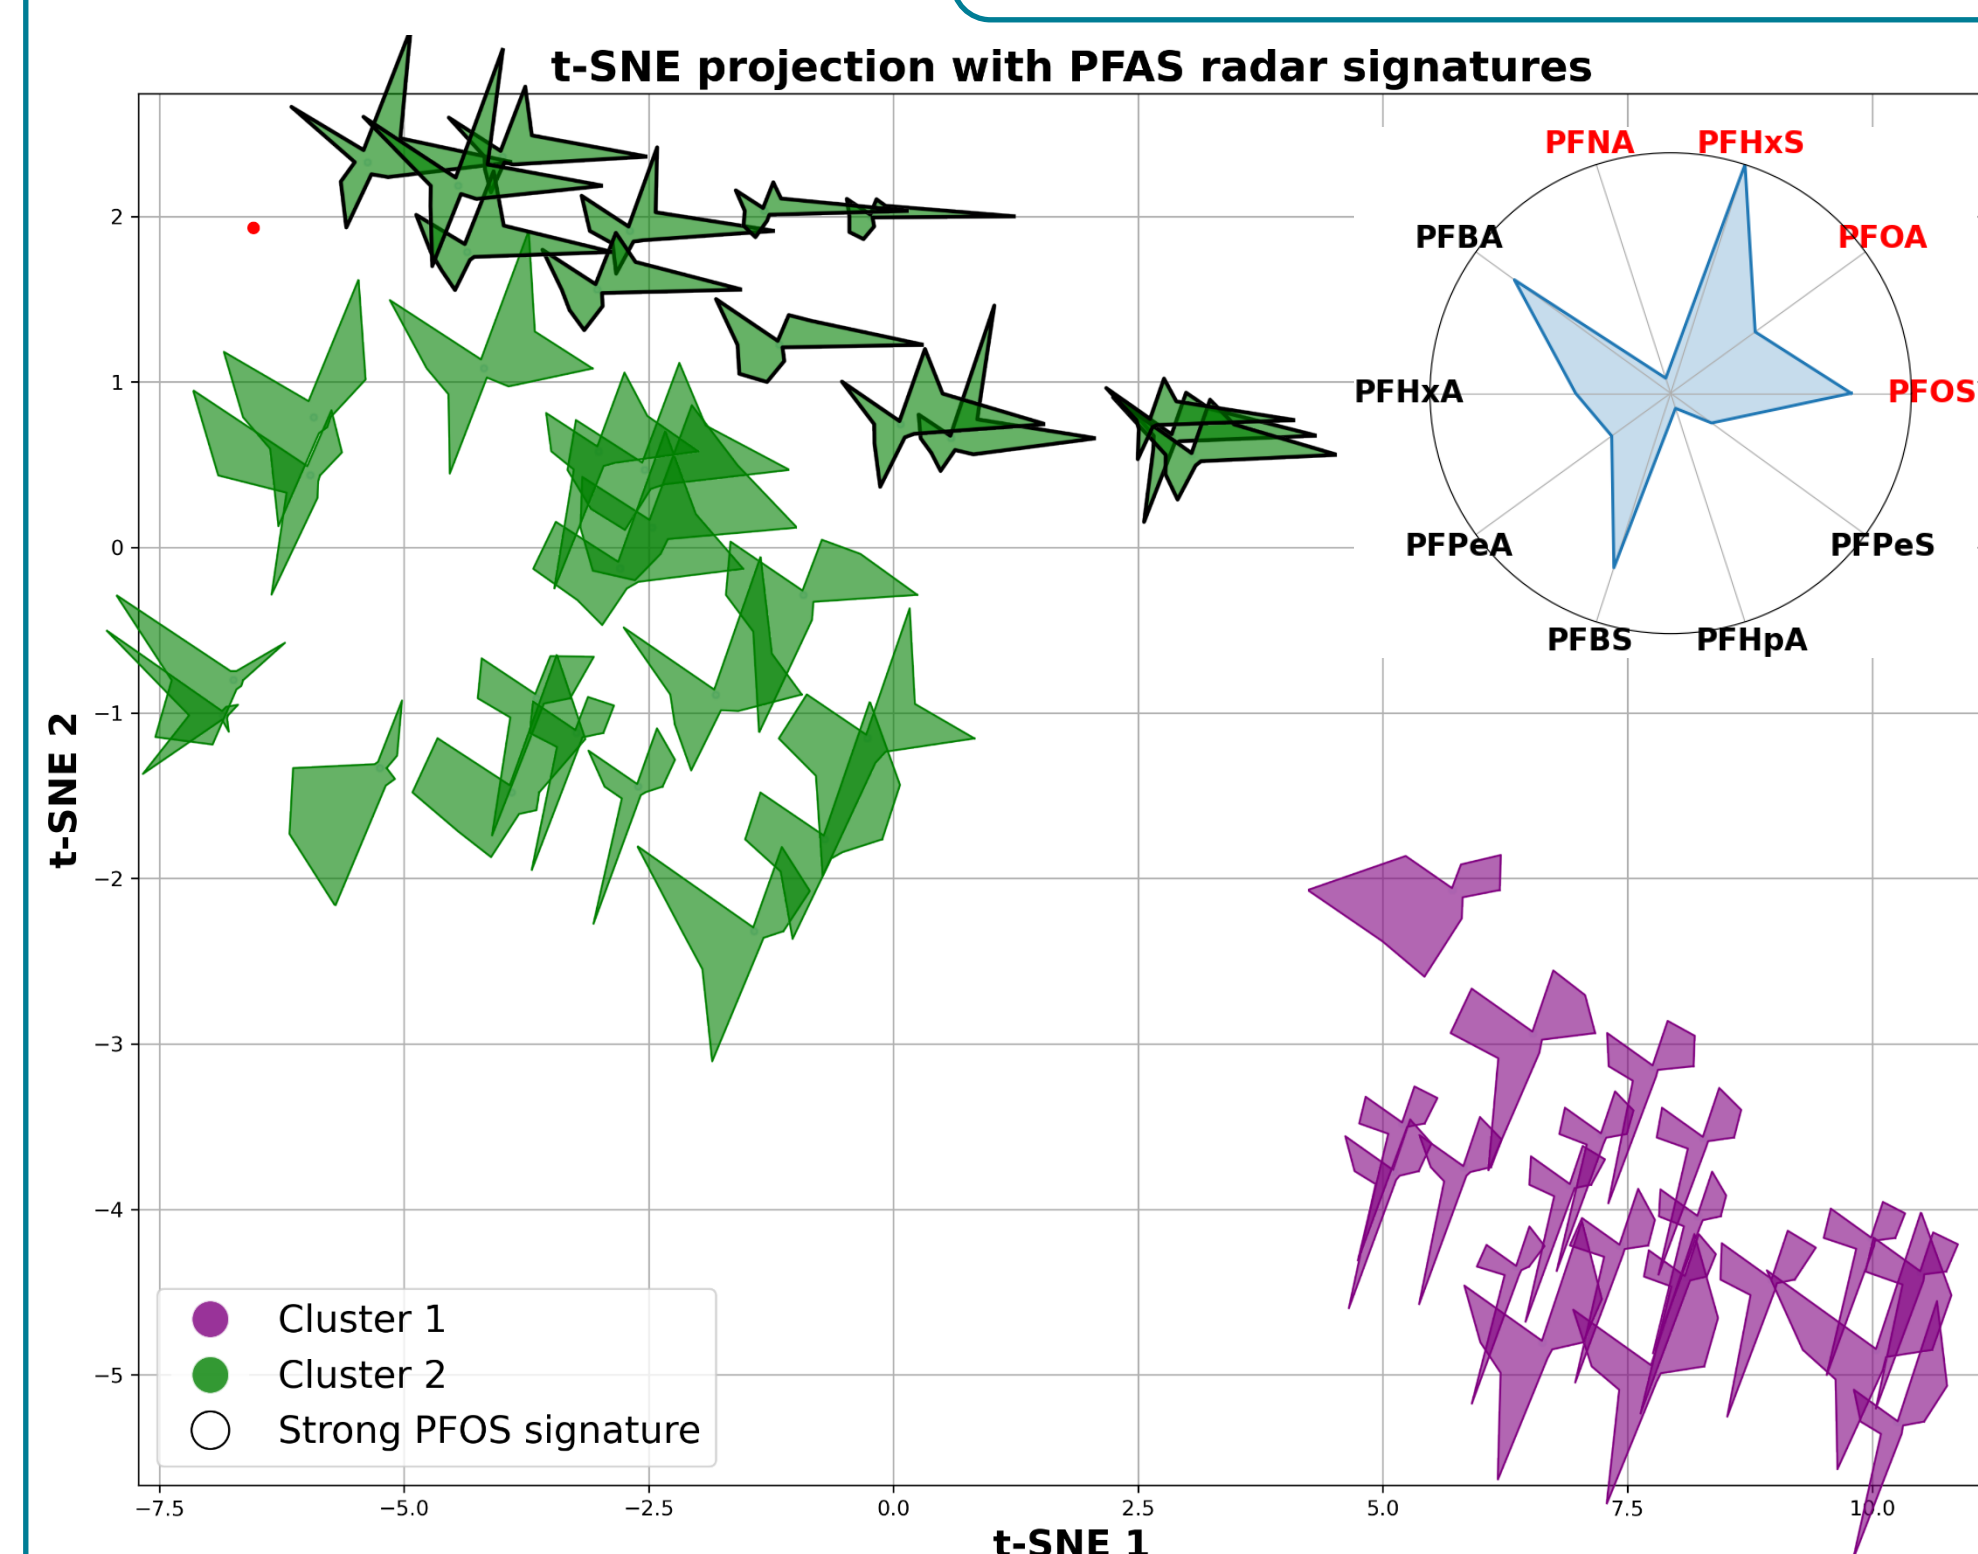
Radar & t-SNE

Following the PCA, t-SNE analysis was used to enhance the visualization of individuals showing similar PFAS profiles, based on their proximity in the PCA space.

This analysis revealed two distinct clusters: a purple group, representing individuals with the highest PFAS concentrations, and a green group, corresponding to those with lower concentrations. In addition, PFAS radar signatures were used to identify piezometers showing a distinct PFOS peak.
