Bioelectrochemistry

Corrosion behaviour and biocorrosion of galvanized steel water distribution systems

F. Delaunois, F. Tosar, V. Vitry*

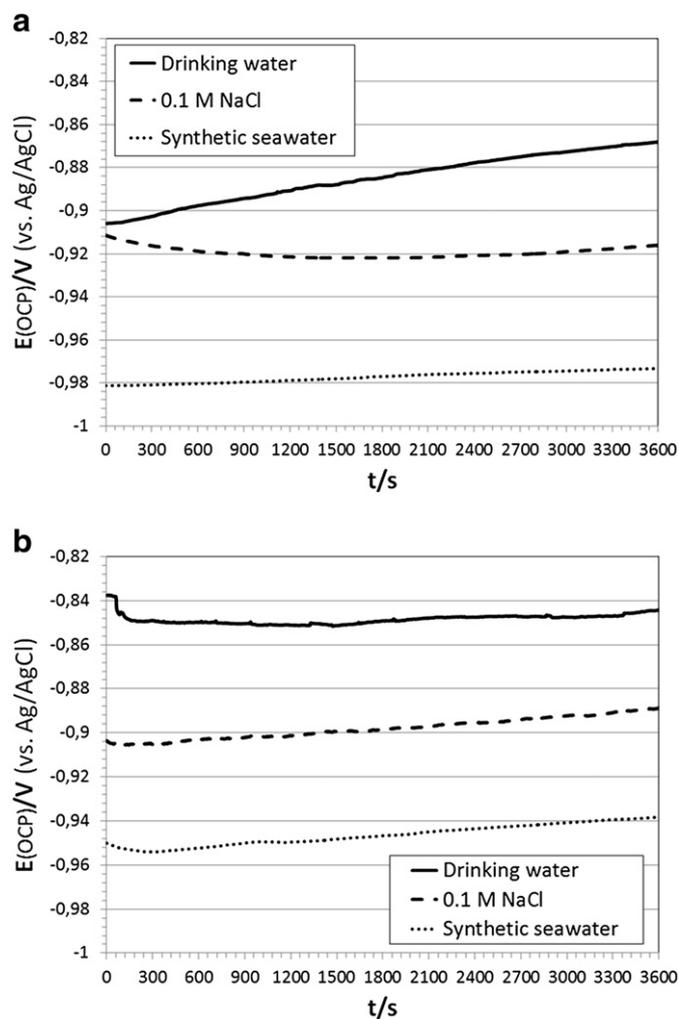
Fig. 7 shows the evolution of the OCP of 2 galvanized steel tubes during 60 min of immersion in various electrolytes: one presents a zinc coating with an adequate microstructure and homogeneous thickness (over 55 μm) and is exempt of defects (named “good galvanized steel tube”; Fig. 7(a)) and one has a galvanized coating of lesser (bad) quality, with the presence of many defects, inadequate microstructure and heterogeneous thickness (named “bad galvanized steel tube”; Fig. 7(b)). As expected [11,23,27], the OCP shifts gradually towards more positive values and thus the behaviour of the system becomes nobler due to the formation of a passive layer on the top of the zinc during the immersion in the electrolyte in the case of good galvanized steel, excepted in 0.1 M NaCl. Actually, in 0.1 M NaCl, the zinc coating is attacked by chloride that degrades the coating protection at the beginning of immersion. After about 40 min of immersion, the OCP becomes nobler with the formation of the corrosion products. In artificial seawater electrolyte, the activity of sodium chloride is weakened by the presence of other ions such as K^+ , Mg^{2+} , Ca^{2+} and SO_4^{2-} . In the case of bad quality galvanized steel tube, during the very first moments of immersion, the OCP shifts to less noble values due to enhancement of the anodic dissolution of the coating. When corrosion products are deposited on the surface, the potential gradually shifts in the noble direction. Moreover, this effect

Fig. 7. Open circuit potential E_{OCP} of good quality (a) and bad quality (b) large galvanized steel tube in various electrolytes vs. time of immersion.

Electrochemical studies of corrosion provide information about corrosion behaviour of galvanized steel tubes in water. Firstly, after immersion in drinking water and in synthetic seawater, OCP (Fig. 7) of the good galvanized steel tubes becomes more positive due to the formation of a passive layer of zinc oxides. Bad galvanized steel tubes have more trouble to form an effective passive layer in all the electrolytes that were studied. Secondly, Tafel curves (Fig. 8) indicate that the corrosion process is totally or partially dependent on diffusion through the layer of corrosion products. Table 2 shows that the rate limiting step is the mass transfer of corrosion reagents due to the zinc deposit acting as a barrier coating, controlling the reaction of dissolved oxygen [11,23,27]. Thus, corrosion by neutral aerated water is not promoted but this oxygen gradient is favourable for anaerobic bacteria which find a friendly environment. Finally, Nyquist plots (Figs. 9 and 10) and EIS analysis (Figs. 11 and 12) confirm this observation. Actually, the LF arc or tail indicates a diffusion process through a finite thickness layer (the corrosion products), related mainly with the reduction of dissolved oxygen, due to the absorbed species that contribute to the formation of the corrosion layer. The HF–MF arc is attributed to faradic charge transfer, associated with the effect of ionic double layer capacitance. This complex mass transport mechanism is due to the system formed by corrosion medium/corrosion products/metal [11,23]. Diagrams at LF give information on the barrier effect of the coating. The appearance of diffusion tails at LF can be linked to the accumulation of corrosion

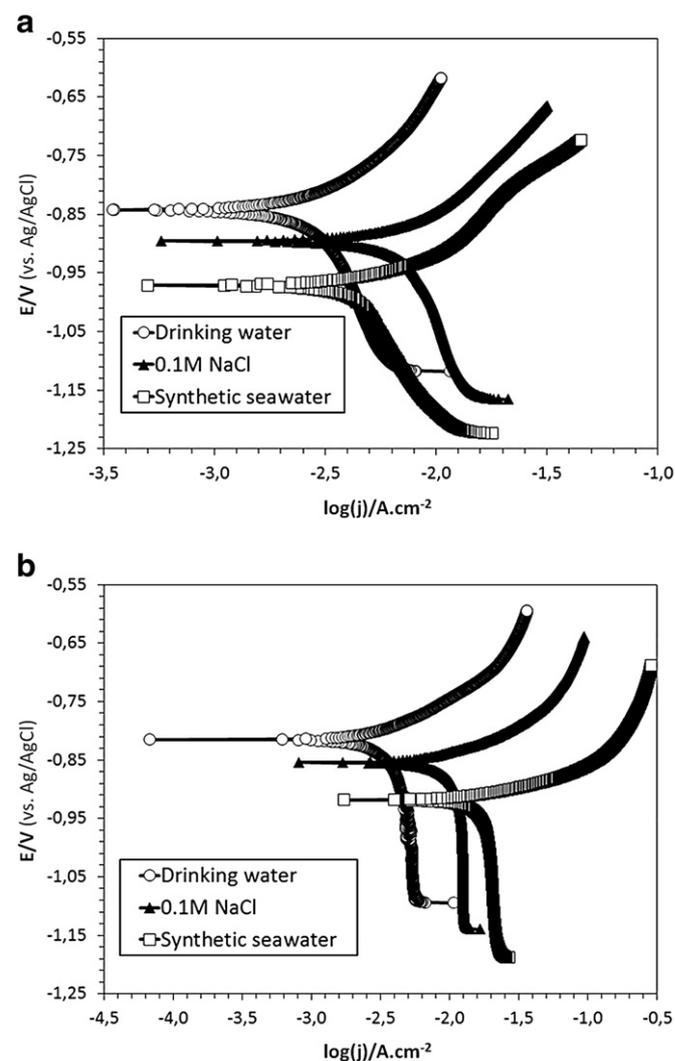
Fig. 8 shows the Tafel plots of the polarization curves from a good quality galvanized steel tube (Fig. 8(a)) and a bad quality galvanized coating (Fig. 8(b)) in various electrolytes. Before starting the measurement, samples are kept in 0.1 M NaCl solution for 15 min, to allow the covering of the coating surface by a very thin layer of zinc oxide [27]. Values of the electrochemical corrosion parameters (corrosion potential E_{corr} (V vs. Ag/AgCl), corrosion current density j_{corr} ($\mu\text{A}/\text{cm}^2$)) are shown in Table 2.

Table 2 shows that, for each electrolyte used, the corrosion potential E_{corr} of the good and bad quality galvanized steel tubes are in the same range if the standard deviation is taken into account. The presence of chloride in important concentration causes a shift in corrosion potential to more negative values compared to drinking water. Moreover, the corrosion current density j_{corr} is higher for the bad quality galvanized coating whatever the electrolyte. For the good quality galvanized steel tube, as expected from the OCP results, the corrosion current density j_{corr} for 0.1 M NaCl electrolyte is higher than that for artificial seawater electrolyte due to the higher activity of the chlorides in 0.1 M NaCl. Fig. 8 shows that, at the beginning of the anodic branch of the Tafel curves, the current sharply increases and there is no passive region. The increasing potential is then responsible for the active dissolution of zinc and dissolution continues until the zinc surface is covered by a layer of corrosion

Fig. 8. Potentiodynamic polarization curves of a good quality (a) and bad quality (b) large galvanized steel tubes in various electrolytes.

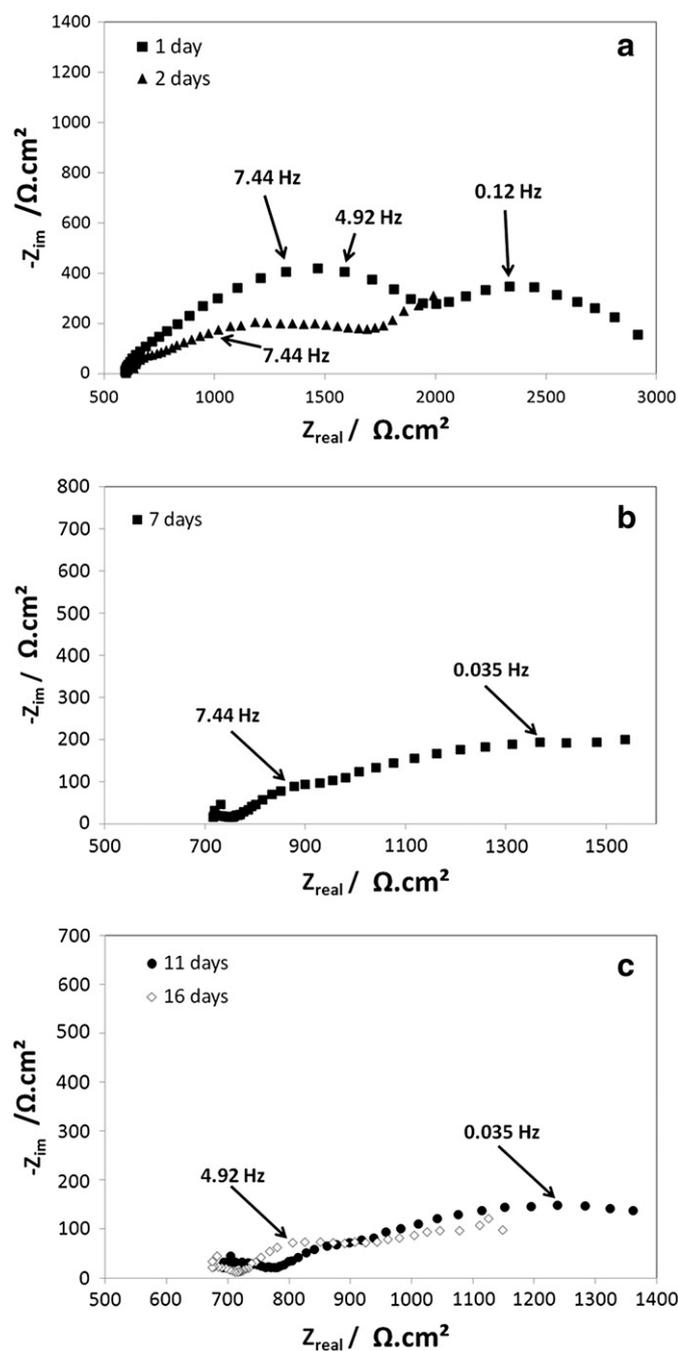
Fig. 9. Nyquist plots of Electrical Impedance Spectroscopy data for 1–2 days (a), 7 days (b) and 11–16 days (c) of immersion in 0.1 M NaCl of a large galvanized steel tube (imaginary part vs. real part of complex impedance).

In 0.1 M NaCl solution (Fig. 9), we observed an arc (or depressed semicircle) at high and medium frequencies (HF–MF) followed by a second arc at low frequency (LF) (Fig. 9(a)). As the immersion time increases, the LF arc or tail becomes more important and the high frequency–medium frequency (HF–MF) arc is seriously depressed. Nyquist impedance curves obtained in drinking water (Fig. 10) can be interpreted similarly. Moreover, the solution resistance is higher in drinking water than that in 0.1 M NaCl solution and the diffusion process at LF is more noticeable.

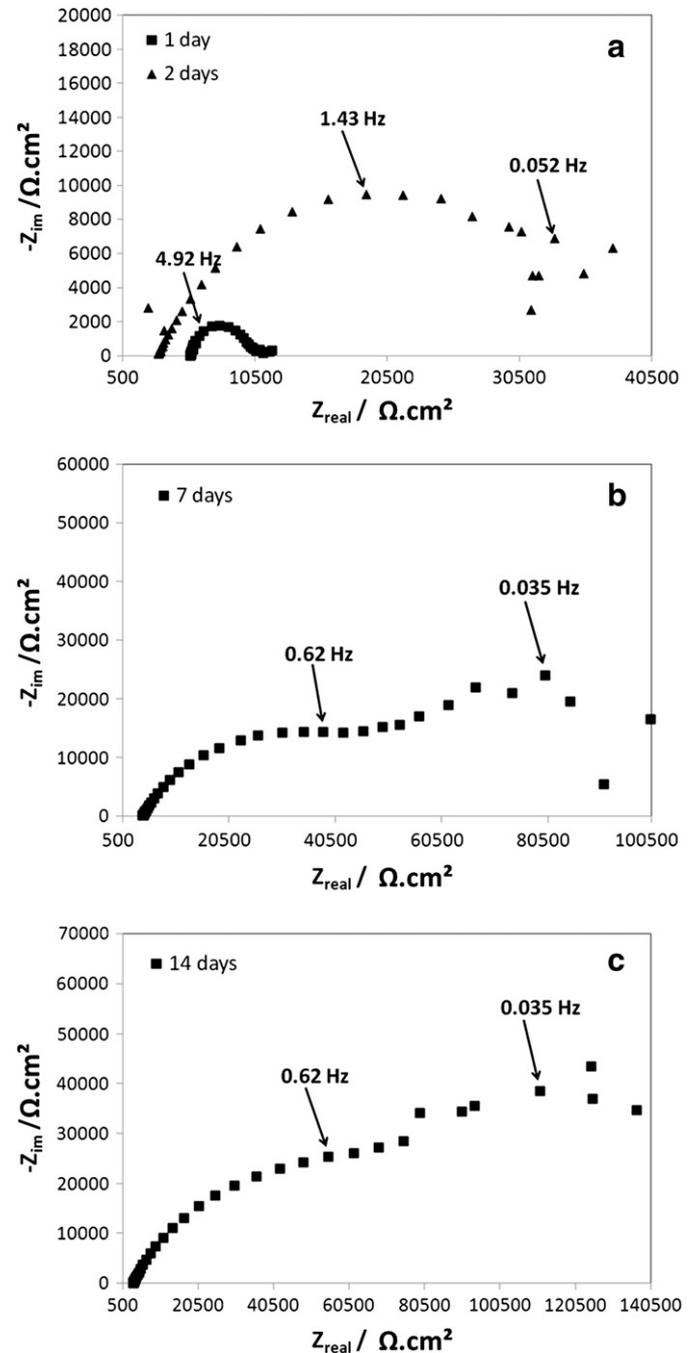
Fig. 10. Nyquist plots of EIS data for 1–2 days (a), 7 days (b) and 14 days (c) of immersion in drinking water of a large galvanized steel tube (imaginary part vs. real part of complex impedance).

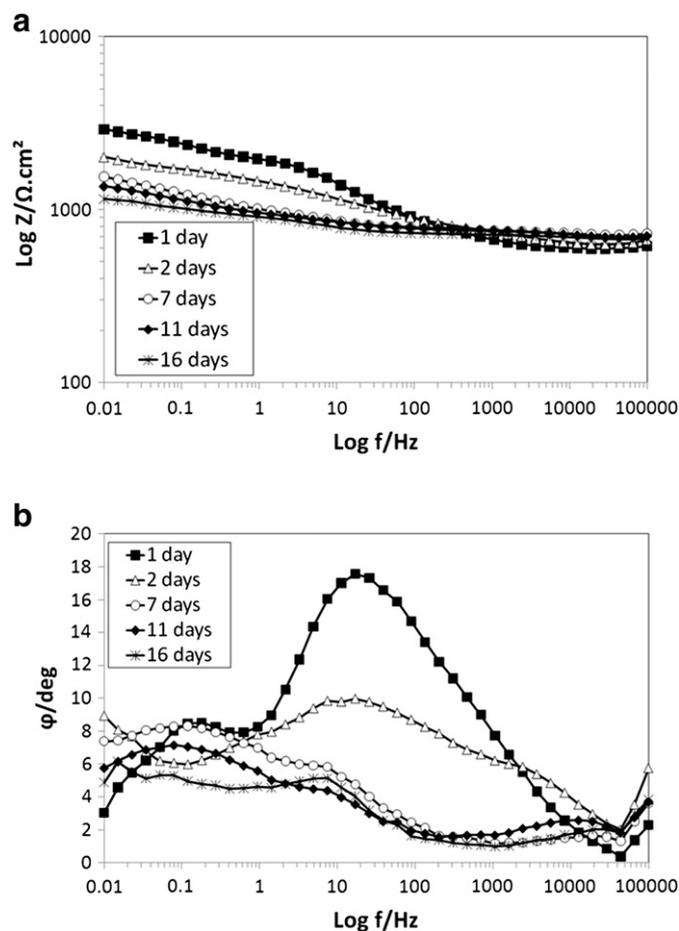
In 0.1 M NaCl solution (Fig. 11), the low frequency impedance modulus value (Fig. 11(a)) that reaches $3.10^3 \Omega \cdot \text{cm}^2$ after one day of immersion, decreases slowly with immersion time to about $10^3 \Omega \cdot \text{cm}^2$, due to chloride attack of the coating and to the dissolution of zinc. This shows a nearly resistive behaviour of the coating. At low frequencies, the phase angle is less than 10° (Fig. 11(b)). During the first days of immersion, two time constants are detected at low and medium frequencies due to electrochemical activity. The low frequency time constant is attributed to corrosion processes and its shift to lower frequency with immersion time is due to the slowdown of the process related to the diffusion through corrosion products. The appearance of a third time constant at low frequencies after long periods of immersion points out the degradation of the coating. The medium frequency time constant generally relates to the coating. The increase of the phase angle in the low frequency range after 2 days of immersion accounts for corrosion

Fig. 11. Bode plot of EIS data for 1–16 days of immersion in 0.1 M NaCl of a large galvanized steel tube (Bode modulus vs. frequency (a) and Bode phase vs. frequency (b)).

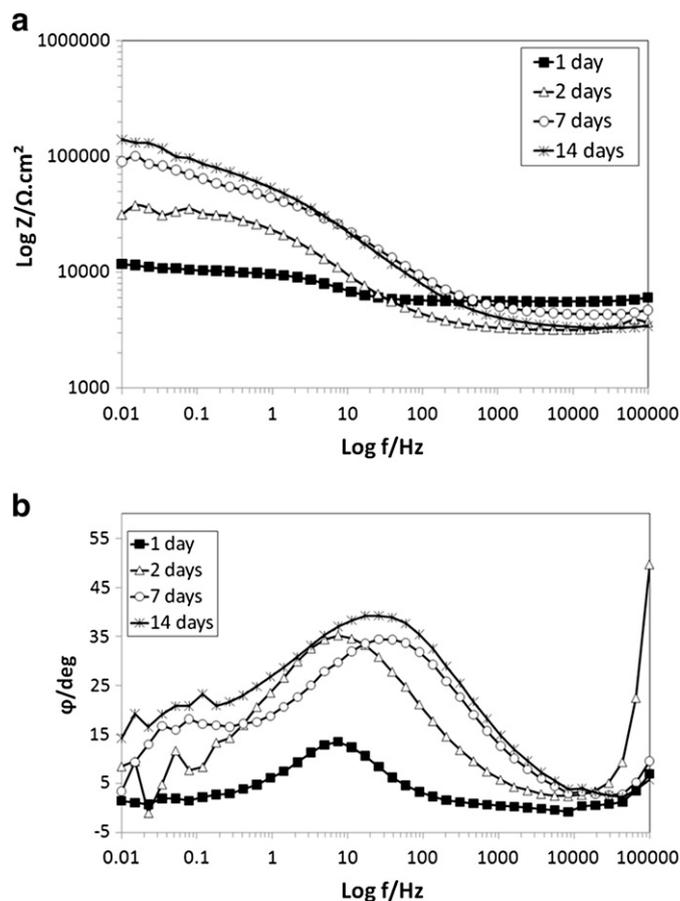
Fig. 12. Bode plot of EIS data for 1–14 days of immersion in drinking water of a large galvanized steel tube (Bode modulus vs. frequency (a) and Bode phase vs. frequency (b)).

In drinking water (Fig. 12), the observed phenomena are different. The low frequency impedance modulus increases with immersion time from about $10^4 \Omega \cdot \text{cm}^2$ after one day of immersion to reach more than $10^5 \Omega \cdot \text{cm}^2$ after 14 days (Fig. 12(a)). This is due to the formation of a protective zinc hydroxide layer on the surface of the coating. In the Bode phase diagram (Fig. 12(b)), after one day of immersion, we observe only one time constant at medium frequencies related to the coating. At low frequencies, the phase angle that is close to zero degree during the first days of immersion increases to 15° after 14 days of immersion. After 7 days of immersion, two time constants are detected at low and medium frequencies due to corrosion processes.
