## Non-Destructive Testing by Ultrasonic and Thermal Techniques of an Impacted Composite Material

**Abstract**— The aim of this work is to control the state of the structure of a composite material after low velocity impact. In fact, the impact damage is one of the most critical flaws that can reduce the intrinsic characteristics of a composite structure drastically. The diagnostic of composite laminates in this case will be very difficult, because during impact several modes of failure appear (matrix cracking, delamination and fiber breakage), and it can be often not visible on the surface. For this reason it will be necessary to use the non-destructive techniques (NDT) of control to make sure of the state of the material without damaging it. This paper presents some methods of control to detect and characterize defects appeared after low velocity impact on a hybrid composite plate of epoxy resin reinforced with carbon fiber. The methods used in this work are considered among the most used in the control of composite material. Indeed, each technique has advantages and disadvantages. Therefore, the use of several control techniques ensures the diagnosis, so we talk about the compl

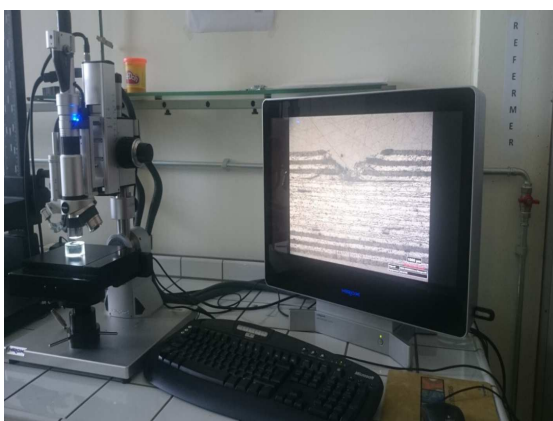
Fig. 7 Digital microscopes / 3D display microscopes.

Thanks to a digital microscope KH-8700, it is possible to extract and record fastly and with a high quality the three dimensional shape of the surface as well as the damages left by the impactor on the whole specimen (Fig. 7).
