International Biodeterioration & Biodegradation

Antifouling properties of different Plasma Electrolytic Oxidation coatings on 7075 aluminium alloy

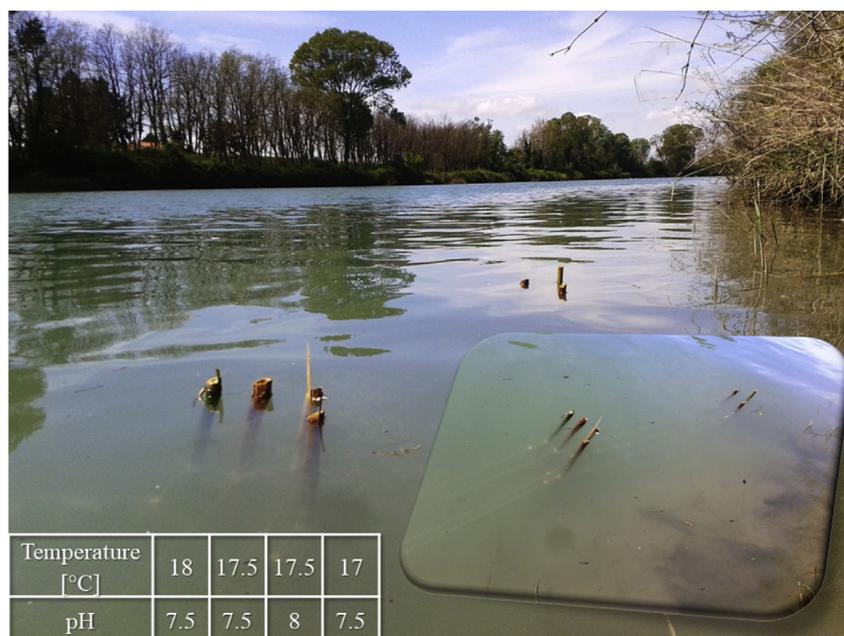
Fig. 1. Image of the place selected for the antifouling tests with the samples immersed in the river water. In the table on the bottom left are reported the pH and temperature values recorded at the four sampling times.

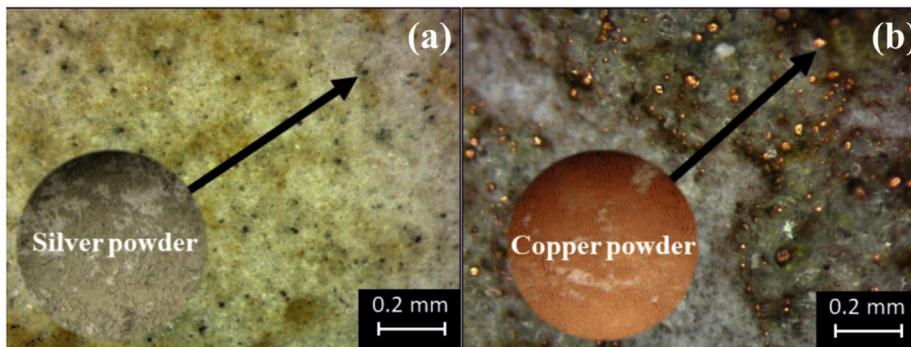
Fig. 2. Image of the two PEO coatings obtained with silver (a) and copper (b) powder. The particles are clearly visible on the surfaces.

The PEO coating without additives was produced working at high current densities and short treatment times and the complete characterization of the PEO treated sample is reported in (Pezzato et al., 2016). The stereomicroscope observation of the surfaces of the samples treated with silver and copper particles in the electrolyte can be observed respectively in Fig. 2a and 2bb. Moreover, the coating seemed to

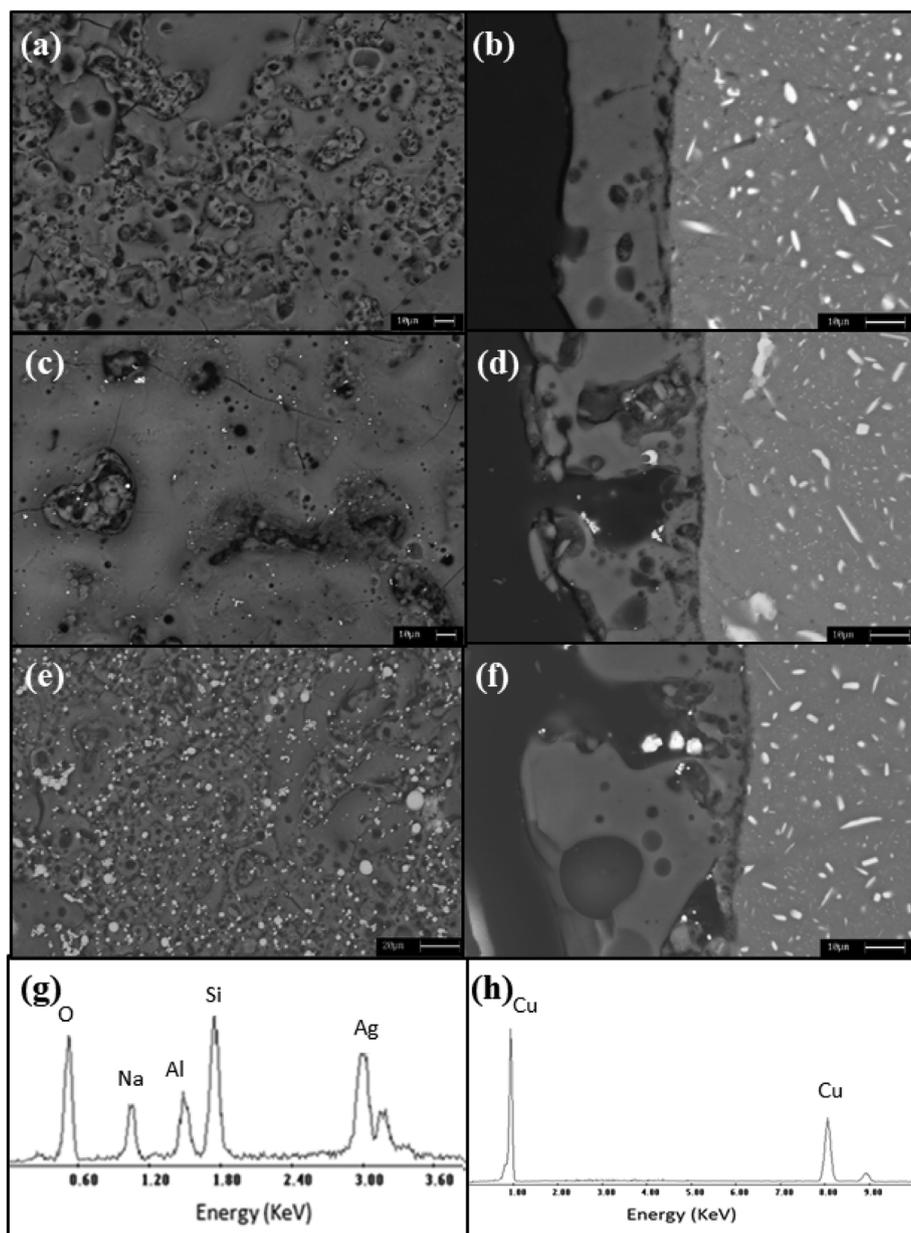
Fig. 3. Image of the surface and section of the PEO coatings with and without silver and copper powders. (a) surface of sample without particles; (b) section of sample without particles; (c) surface of sample with silver; (d) section of sample with silver; (e) surface of sample with copper; (f) section of the sample with copper; (g) EDS analysis of the silver particles; (h) EDS analysis of the copper particles.

The EDS analysis at SEM of the coatings containing silver or copper powders revealed the presence of particles both on the surface and inside of the pores characterizing PEO coatings (Fig. 3). The presence of the particles into the electrolyte seemed not to influence the formation and the morphology of the coatings, which was almost the same if compared with that obtained without particles (Fig. 3a and b). In detail, it can be observed the typical surface of PEO coatings rich of pores and micro-cracks (Fig. 3a, c and 3e) and the thickness of the coatings is between 15 and $20 \mu\text{m}$ (Fig. 3b, d and 3f). Analysis of the cross section of the samples highlighted also the typical double layer structure of PEO coatings, with an inner thin and dense layer, called also barrier layer, and an external porous layer, called technological layer (Jiang and Wang, 2010). Moreover, from the surface observation, the pores resulted partially sealed by the sealing treatment in boiling water. EDS analysis of the white spots, observed at SEM in backscattered electron mode, revealed that these spots correspond to the silver (Fig. 3g) and copper particles (Fig. 3h). From the semi-quantitative EDS analysis, performed on the cross section of the samples, areas without the particles did not show remarkable differences in the composition: aluminum and silicon compounds with oxygen (Table 2). Moreover, the composition of the coating is not influenced by the presence of the particles and it is in accordance with the composition of the electrolyte and substrate.

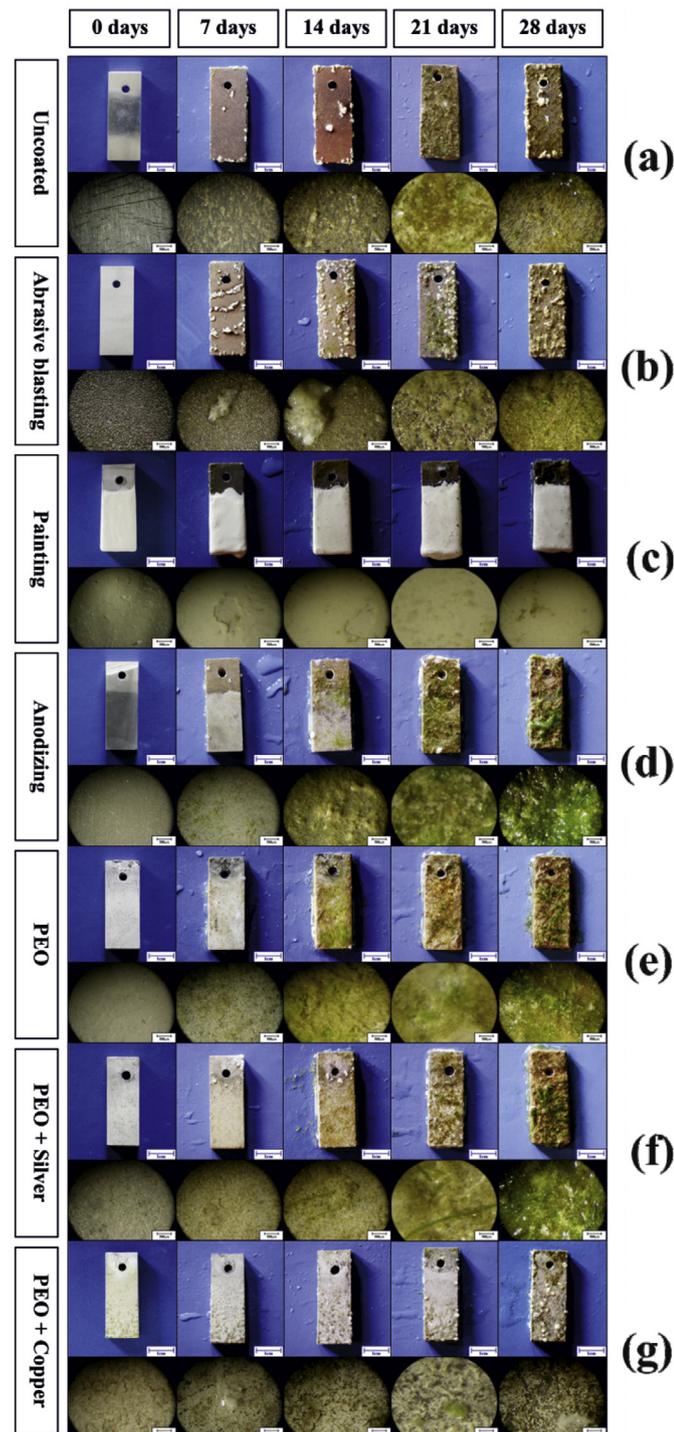
Fig. 4. Image of the samples used for the antifouling test.

The samples and their observation at the stereomicroscope during the antifouling test were shown in Fig. 4.

As it can be observed, the uncoated and abrasive blasting samples after 28 days exhibited the presence of white oxide spots on the surfaces, as expected in the absence of any protective coating (Fig. 4a and b). These white spots are in fact due to corrosion phenomena on the aluminum surface. Moreover, as predictable, the oxidation was more remarkable in the case of sand blasting of the surface, since a greater area was exposed to the water. As regards the colonization by the foulers, the surfaces showed a similar behavior: in fact, even if on one hand the surface roughness, due to the blasting, promotes the settlement of the organisms, on the other hand the higher oxidation, probably due to the substrate dissolution and the release of aluminum ions, could have negative effects on the microalgal adhesion (Gensemer and Playle, 1999).

The commercial antifouling painting treatment on aluminum alloy (Fig. 4c) resulted to have great antifouling and anticorrosive effects, since the surface did not change after the four weeks of immersion and no trace of foulers nor corrosion was detected. The antifouling painting used was a so-called “hard” bottom paint and it is typically applied to fast ships. It differs from other kinds of paintings, like abrasive ones, whose coating gradually wear away releasing the biocide, containing copper oxide particles, and therefore its antimicrobial activity is caused only by chemical action (Almeida et al., 2007). In the case of its application to aluminum alloys, a primer under the paint is necessary in order to avoid galvanic couple and rapid corrosion of the less noble metal (Almeida et al., 2007). The presence of the biocide inside the paint together with the smoothness of the surface allows to the sample to have the greatest antifouling effect.

Even if the anodized sample seemed abundantly colonized already after 21 days (Fig. 4d), at the fourth week, the three samples anodizing (Fig. 4d), PEO coating (Fig. 4e) and PEO coating with silver (Fig. 4f) showed a similar fouling coverage. In particular, it seems that, despite the improved corrosion resistance of these samples in comparison with untreated aluminum alloy, their ceramic coatings offer a substrate more favorable to the settlement of the foulers, due to their chemical inertness. This fact is also connected with the porosity of the PEO surface, because the pores are ideal zones for the colonization of different species, indeed is reported in literature the use of PEO coating as substrate for cell growth (Whiteside et al., 2010). The presence of silver seemed to not increase the antifouling effect of the coating that resulted similar to anodizing PEO samples (Fig. 4f). This fact can be linked with the concentration of silver inside of coating, which was probably not enough to produce an appreciable effect. In detail, for these three treatments, the presence of colonization can be clearly detected already after 14 days of immersion (Fig. 4e and f). However, the presence of the coating remarkably increases the corrosion resistance of the samples, in fact no white oxide spots were detected both in the anodized and PEO coated samples.

On the contrary, the PEO coating with copper powder (Fig. 4g) showed a remarkable antifouling effect. In fact, only after 28 days a weak presence of organisms could be observed. Also the corrosion phenomena on the other treated samples were less than on the untreated sample.

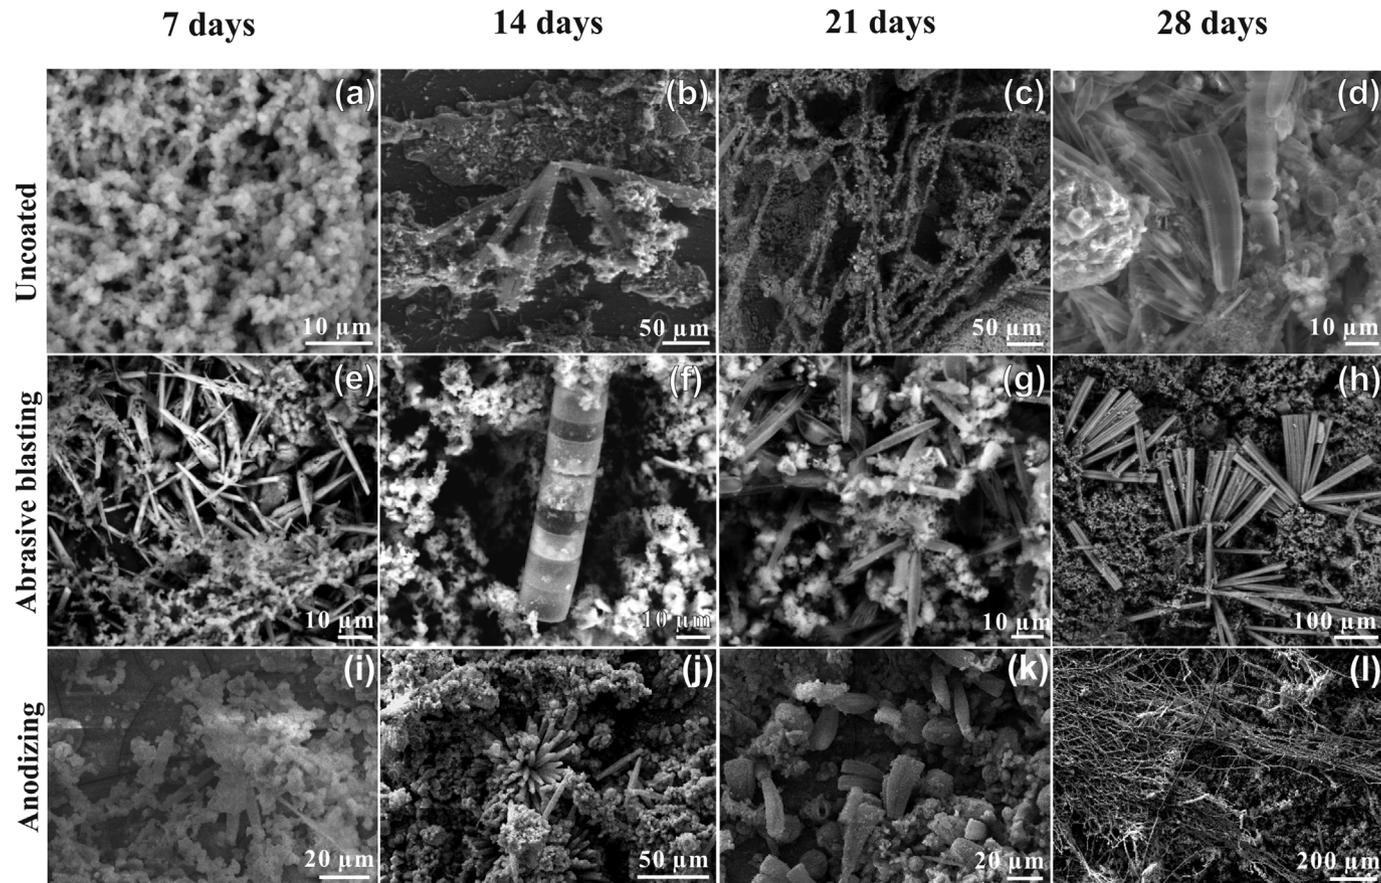
Fig. 5. Scanning electron micrographs of the Uncoated (a–d), Abrasive blasting (e–h), and Anodizing (i–l) samples during the antifouling test (7, 14, 21, and 28 days).

Colonization analyses, carried out by light and scanning electron microscope (Figs. 5 and 6) showed that in all tested samples, except painting, the developed microfouling communities were dominated by benthic diatoms. These photosynthetic microorganisms, together with bacteria and cyanobacteria, are in fact the major constituents of biofilm on submerged surfaces (Callow and Callow, 2002; Patil and Anil, 2015).

Uncoated and abrasive blasting samples, during the first and second weeks, showed the surface covered by inorganic deposit (Fig. 5a and e) and a weak colonization by sessile diatoms, such as *Tabularia fasciculata* (Agardh) D.M. Williams & Round (Fig. 5b) and *Melosira varians* Agardh; while starting from the third week the surfaces of these samples appeared colonized also by chlorophycean filaments (Fig. 5c) and vagile diatoms (i.e. *Amphora* spp. and *Nitzschia* spp.) (Fig. 5g). After 28 days of immersion the coverage was very abundant (Table 3; Fig. 5d and h). The painting treatment, instead, resulted uncovered by foulers during all the tested period (Table 3; Fig. 4).

Anodizing sample since the first week showed a high colonization by diatoms (Fig. 5i), that after 14 days increased both as the species biodiversity and as cell density (Fig. 5j and k). Chlorophycean filaments

appeared during the second week (Table 3) and increased in the following weeks, up till dominated the microalgal community after 28 days (Fig. 5l).

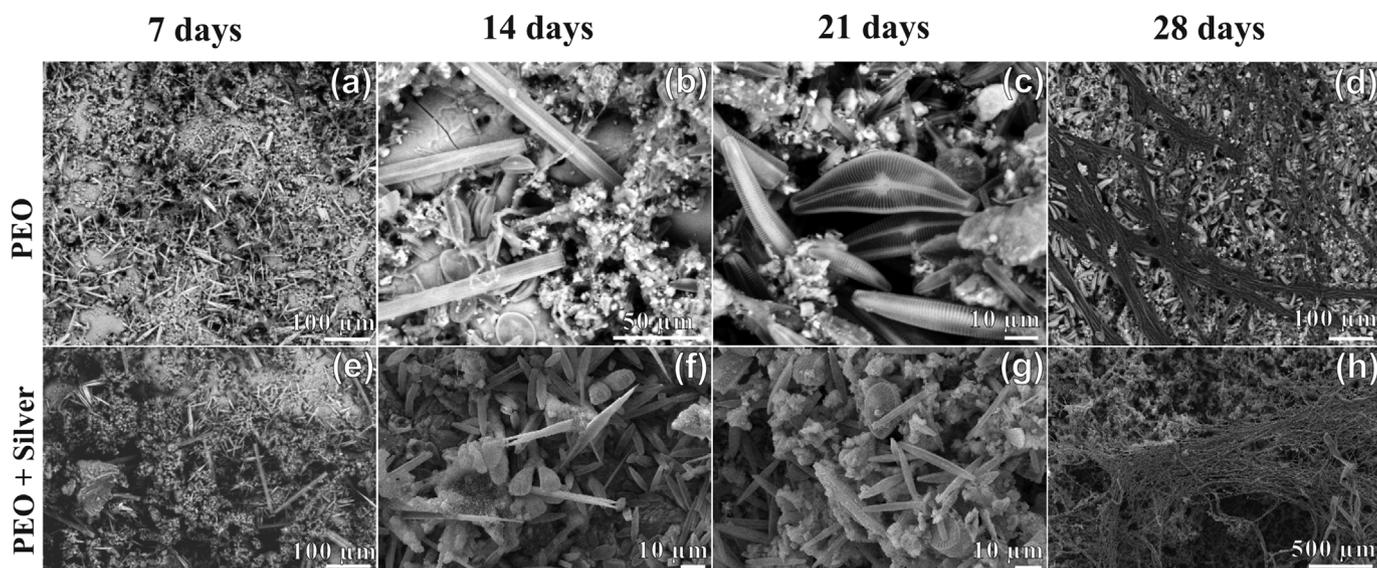
Fig. 6. Scanning electron micrographs of the PEO (a–d) and PEO + Silver (e–h) samples during the antifouling test (7, 14, 21, and 28 days).

PEO coating samples (Fig. 6a and d; Table 3) showed a high coverage ascribable to many species. In particular, pennate diatoms, both sessile and vagile, belonging to the genera *Cocconeis* Ehrenberg, *Synedra* Ehrenberg, *Amphora* Ehrenberg ex Kützinger, *Cymbella* Agardh, and *Rhoicosphenia* Grunow (Fig. 6b and c), contributed to the high biodiversity. In addition, chlorophyceans were present as packed filaments, establishing a living substrate suitable to other microalgal colonizers (epiphytes) (Fig. 6d).

PEO + silver powder coating samples showed coverage slightly lower than PEO ones both in species number and in abundance (Table 3). In particular, since the first week a colonization by diatoms, mainly characterized by stalked taxa, has been observed (Fig. 6e); after 14 days the species diversity and their abundance increased (Fig. 6f; Table 3). A slightly decrease was observed at the third week, with the presence of inorganic precipitates (Fig. 6g). After 28 days, chlorophycean filaments increased such that they dominated diatoms (Fig. 6h; Table 3).

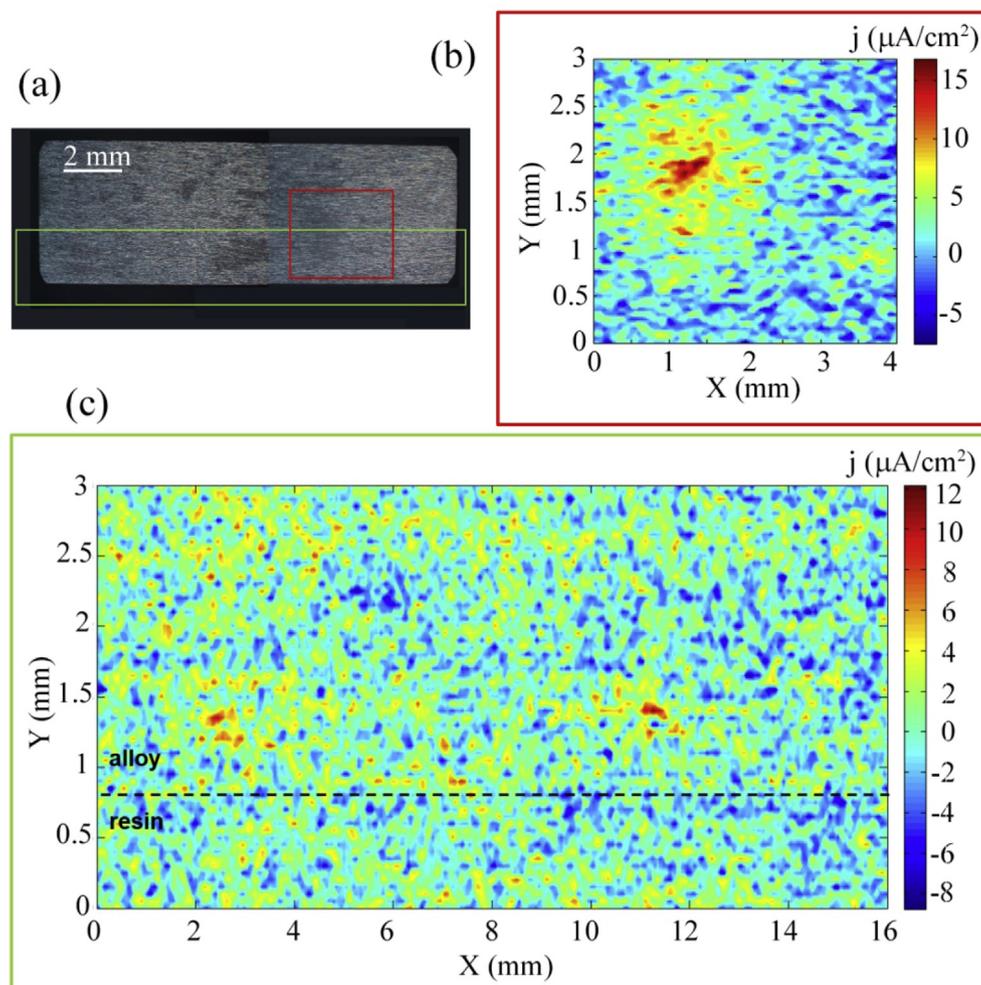
Fig. 7. (a) The resulting cross-section of the PEO + Cu particles-coated AA7075 after 3 h of immersion in 12.00 mM NaCl electrolyte. The corresponding time-dependent current density maps obtained by SVET (b) from 110 to 120 min and (c) from 30 to 80 min of exposure.

The sample comprising the PEO coating containing copper microparticles showed similar results (Fig. 7). The SVET map obtained from the center of the alloy (Fig. 7b) once again indicates the occurrence of anodic attack. In this case, the scan performed along the border (Fig. 7c) could eventually depict clear centers of anodic activity. In general, these centers appear to be established in space and time randomly. The difference in the intensity of the anodic peaks observed between Fig. S3 and Fig. 7 is not necessarily reflective of distinct corrosion rates. Once again, localized phenomena measured by SVET cannot be quantitatively compared, since the probe is necessarily losing information while scanning the surface in a point-by-point fashion.
